# Failure of a Bridge due to Flood in Bangladesh - A Case Study

## Abstract

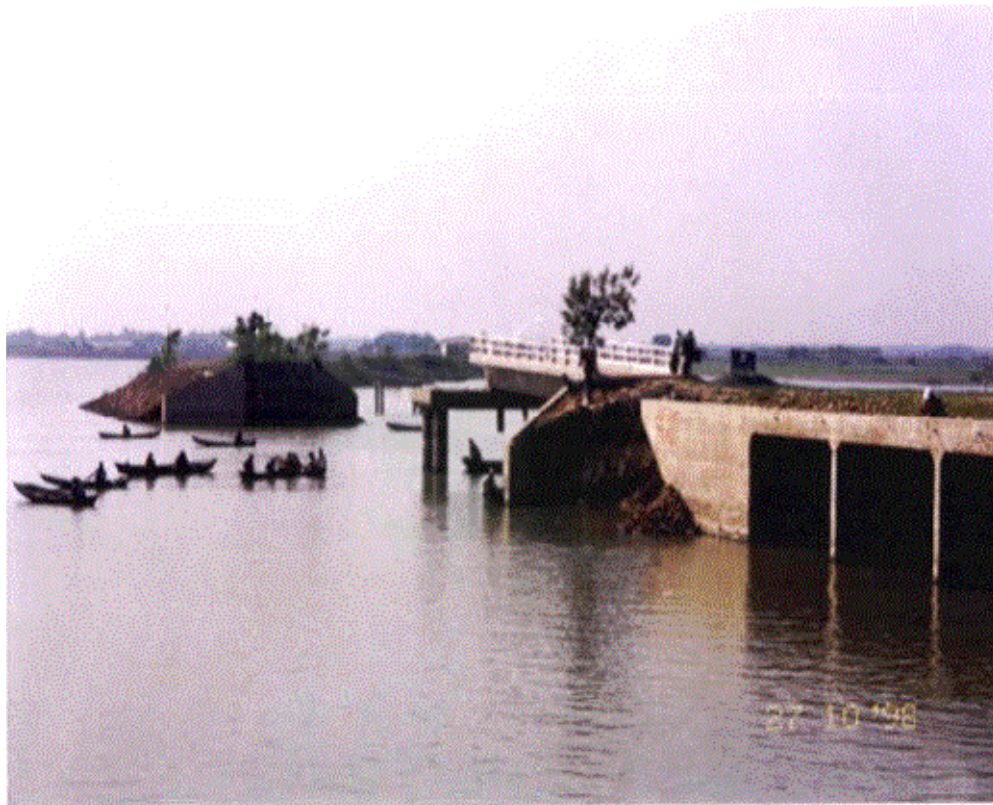
**Photo 2** Damaged 67m bridge during 1998 flood on Turag-Bhakartha road near Amin Bazar

A map of the catchment showing inflow point at Chaira and outflow points on Dhaka-Aricha National High Way and on Turag-Bhakurta road is shown in Fig. 1. Inflow section is only one at Chaira and it is open. There are two bridges on Dhaka-Aricha National High Way acting as outflow sections (Fig. 1). At present there are five existing structures on 1 km Turag-Bhakurta road, which was simple pedestrian before construction of the structures, and had been upgraded and raised after the construction. The five structures function as outflow sections on Turag-Bhakurta road for the catchment (Fig. 1). During 1995 flood, there were only two structures on the road – the damaged 67 m bridge close to Dhaka-Aricha National High Way and another 13 m bridge close to Bhakurta village. So almost the total upgraded road went under water during 1995 flood and worked as outflow section. But during 1998 flood there were already 5 structures on the Turag-Bhakurta road. As 1998 flood was unprecedented, so during the peak time of the flood, the upgraded portion of the Turag-Bhakurta road also went under water and again worked as an outflow section. But at the beginning of flood, five structures on the road functioned as outflow sections. As the floodwater level was gradually rising, the design freeboard kept for the damaged bridge also was slowly reducing and touched the superstructure at the peak time of the flood and high velocity together with an enormous hydraulic pressure of floodwater was put on the bridge. As a result, the two girders together with piers were washed away fully.

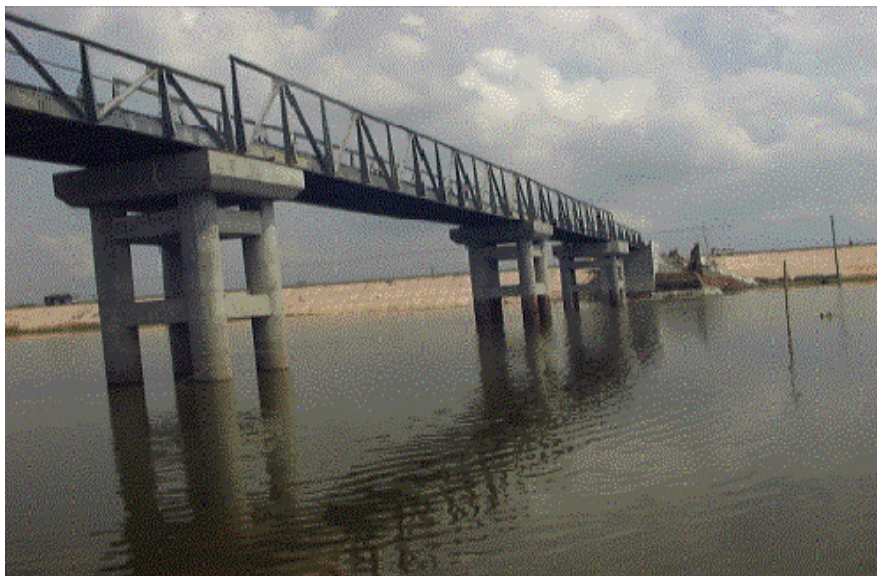
**Photo 3** Newly constructed 100 m bridge in place of damaged 67 m bridge (After: Haque et al., 2002)

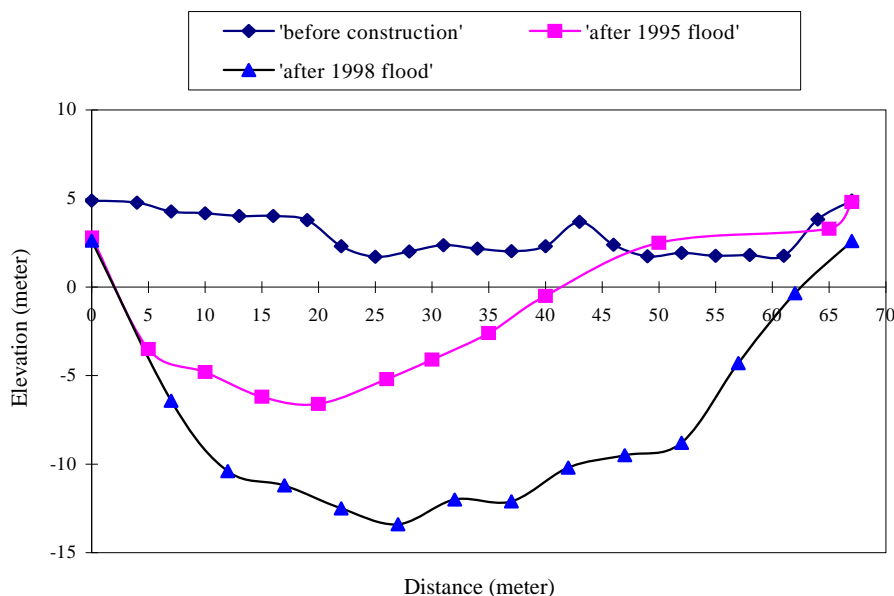
Measurement of cross sections at inflow and outflow points was carried out during survey work. Fig. 2 shows the comparison of cross section before and after 1995 and 1998 floods at damaged bridge section. High Flood Level at Chaira during 1995 was 8.46 m and at damaged bridge site was 7.88 m. As per information of LGED, surface velocity of water through bridge sections (at Chaira and bridge section) was about 2.00 m/s through the mainstream of the section. Haque et al. (2002) carried out a riverbed survey during dry period of 2001 at newly constructed 100 m long bridge for study of scour at abutments and piers. The contour of scour bed as per their survey is shown in Fig. 3.

Fig. 2 Elevation of river bed along the central line of the bridge before construction and after 1995 and 1998 floods
